HISTORIC RESOURCE STUDY

BANNACK STATE PARK

est.
Historical Research Associates
Missoula, Montana

July 1982

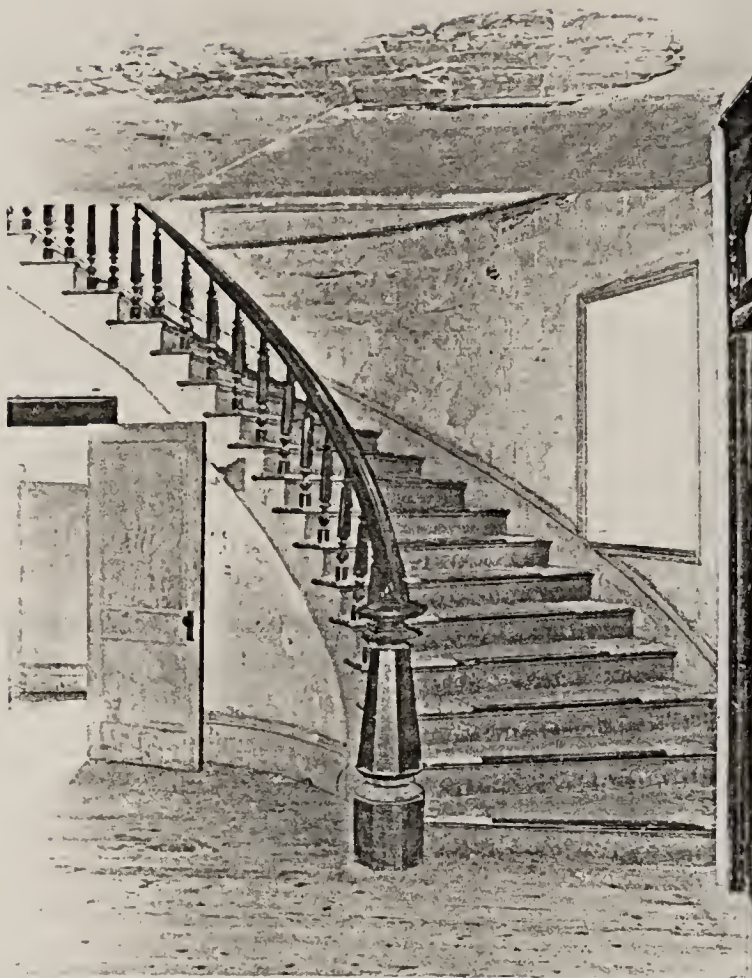
[Some plaster damage]

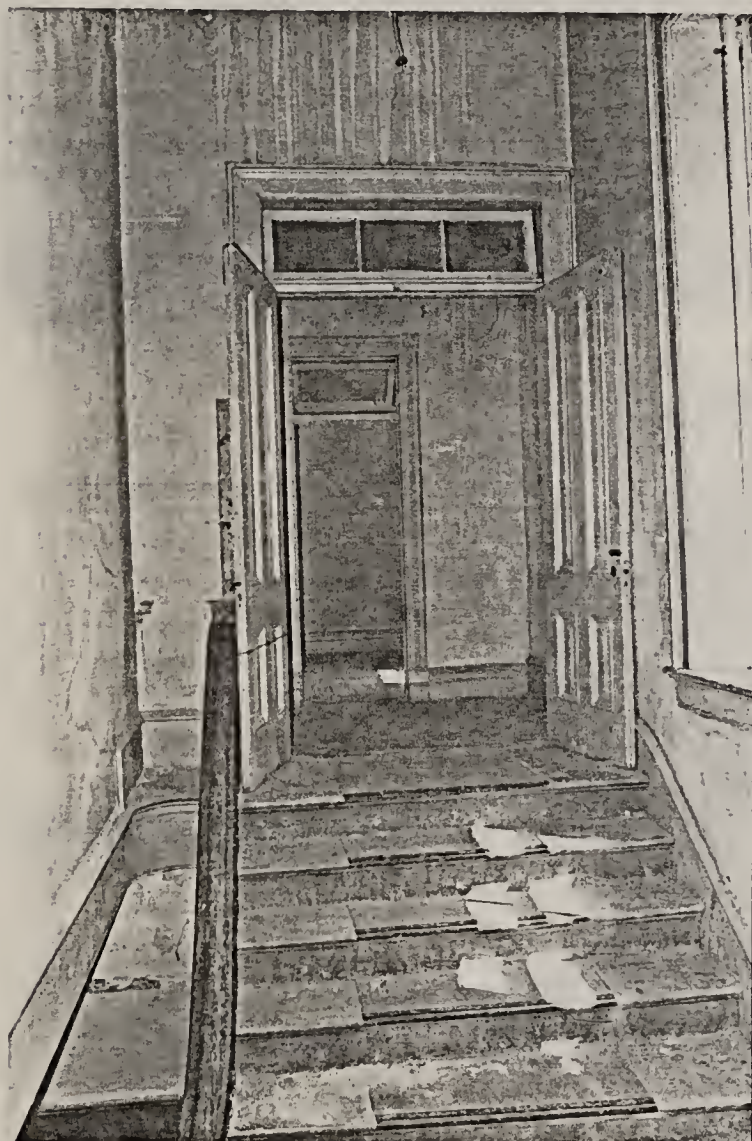
[Water stains from leaking roof]

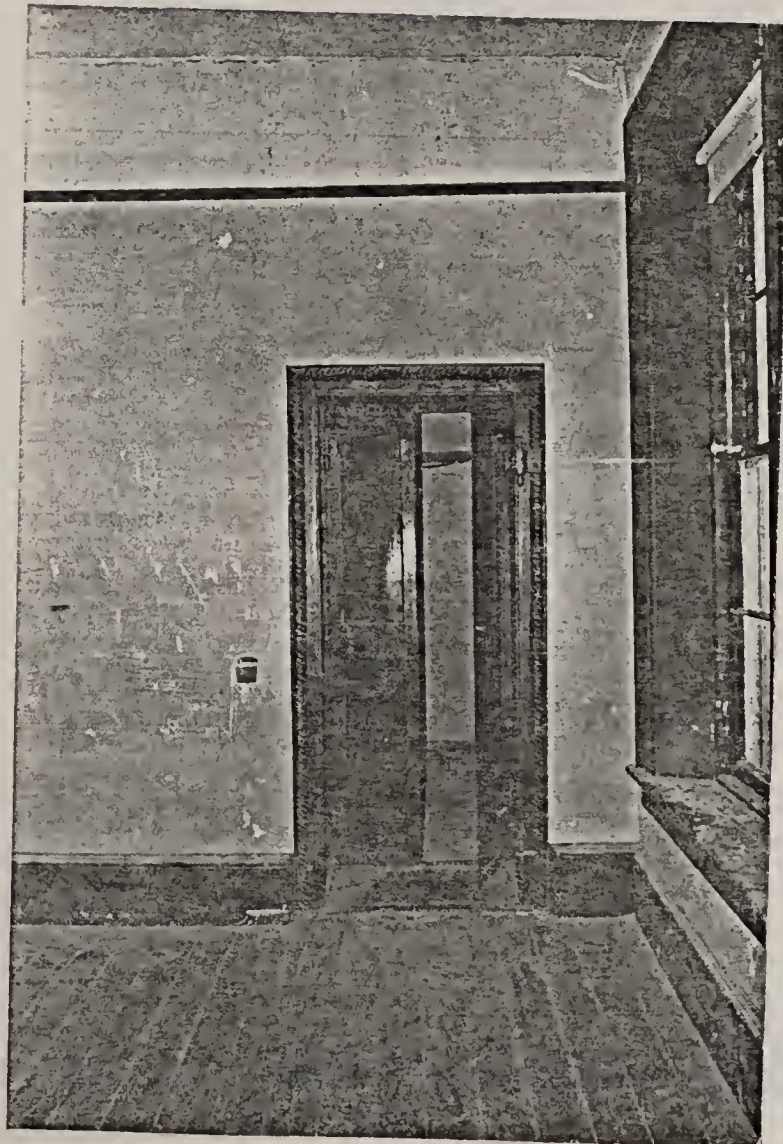
Figure 3-20. Looking at back stair to second floor.

[Plaster missing]

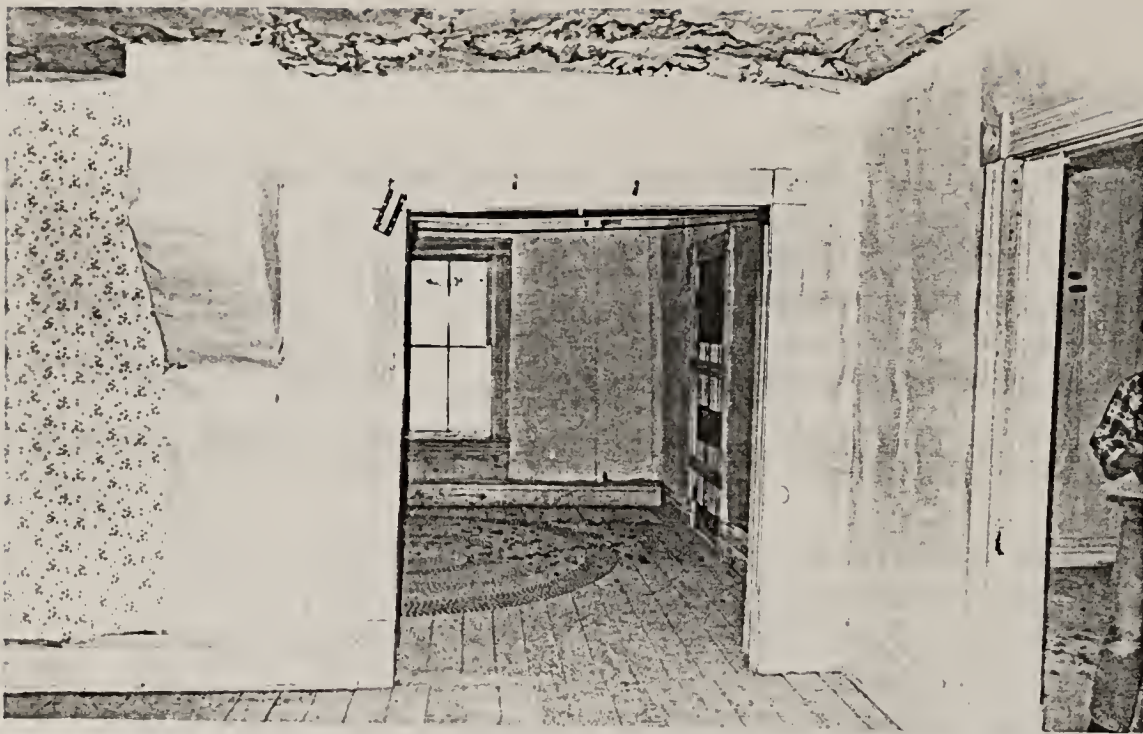
[Water damaged
ceilings]

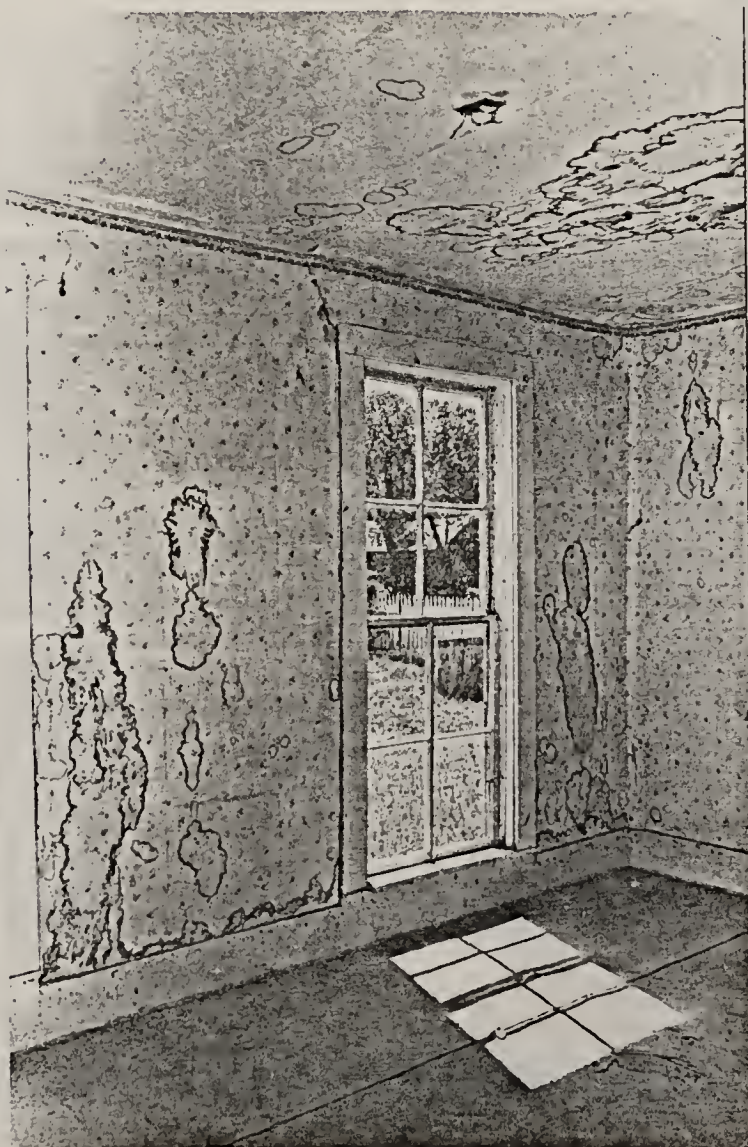
[Water stains from roof leaks]

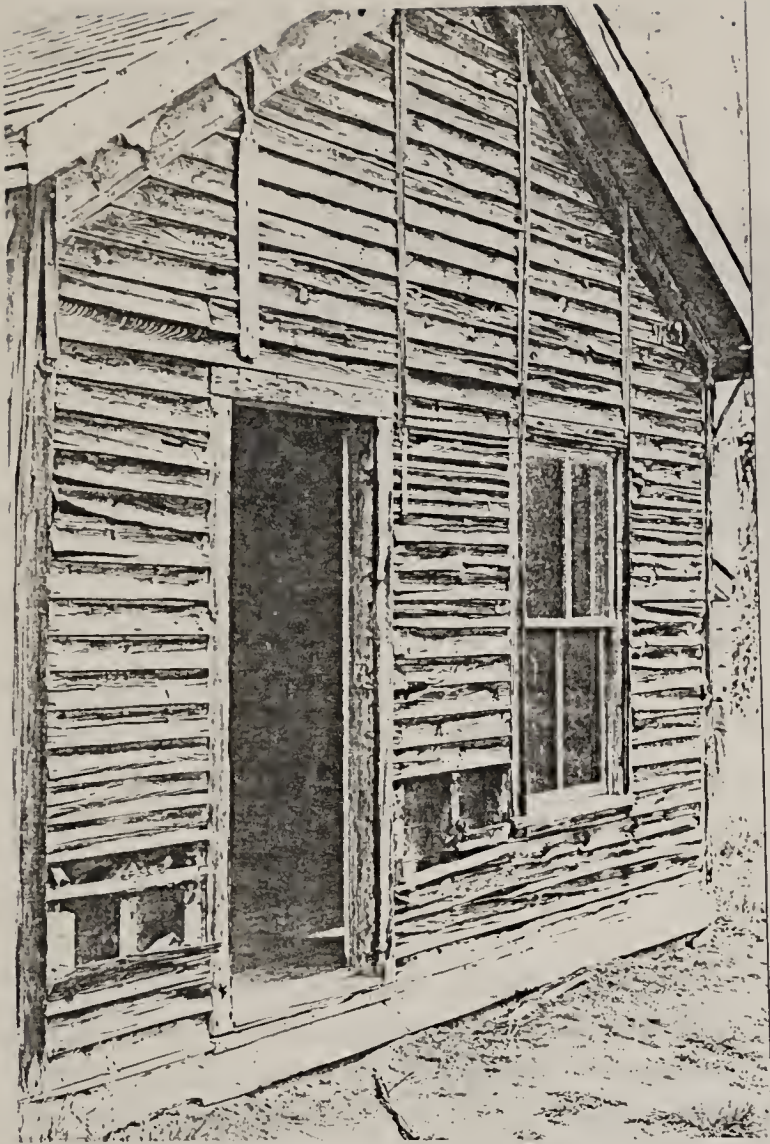
Figure 3-119. Looking northeast to the south facade of the residence.

[Some rot in baseboard and sill]

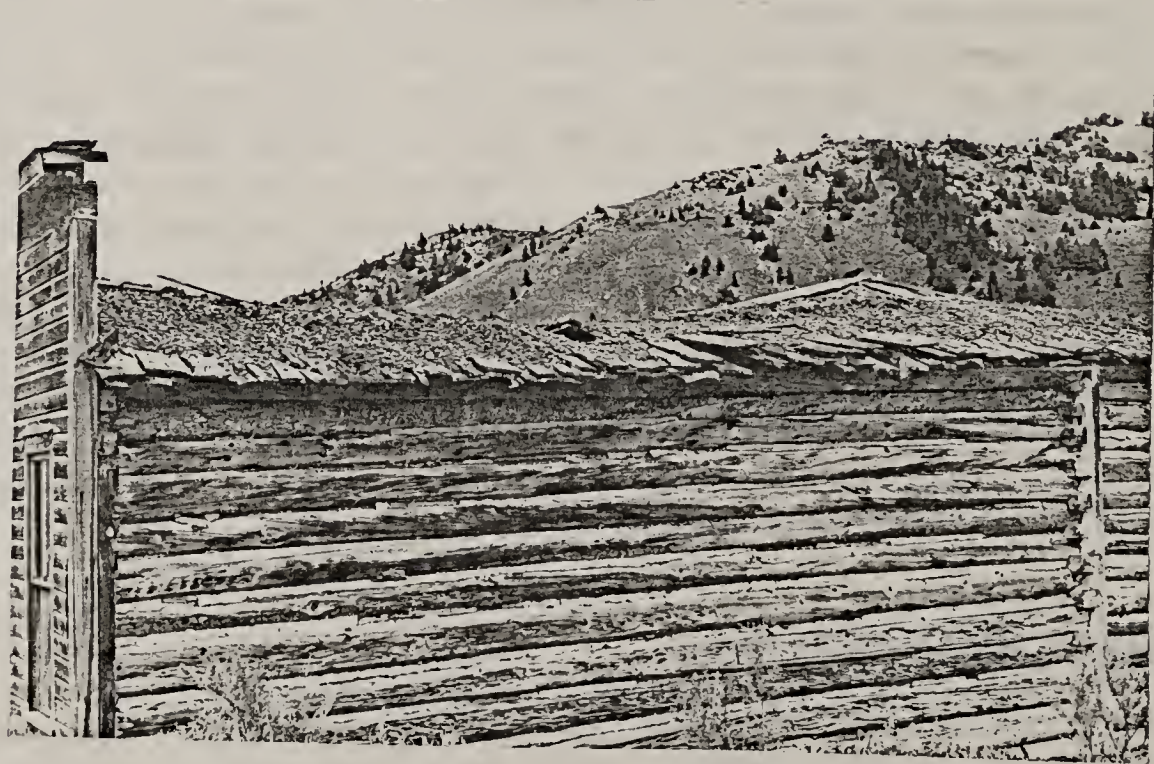
Figure 3-147. Condition of wall and failed roof structure.

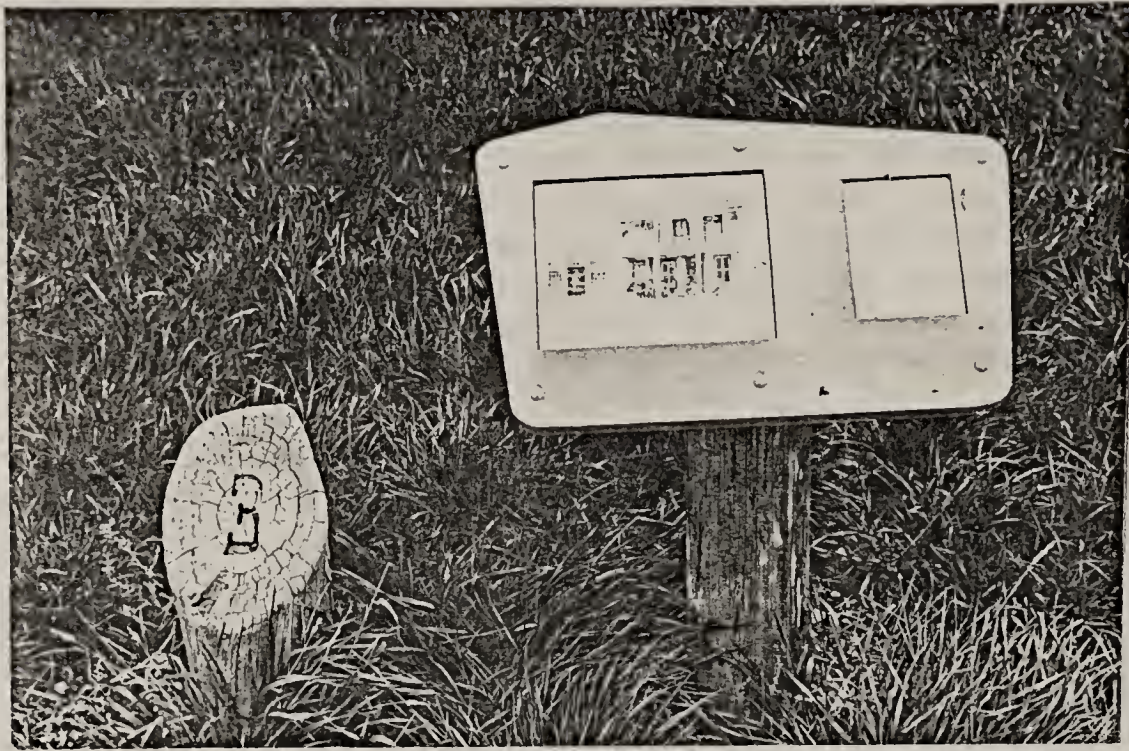
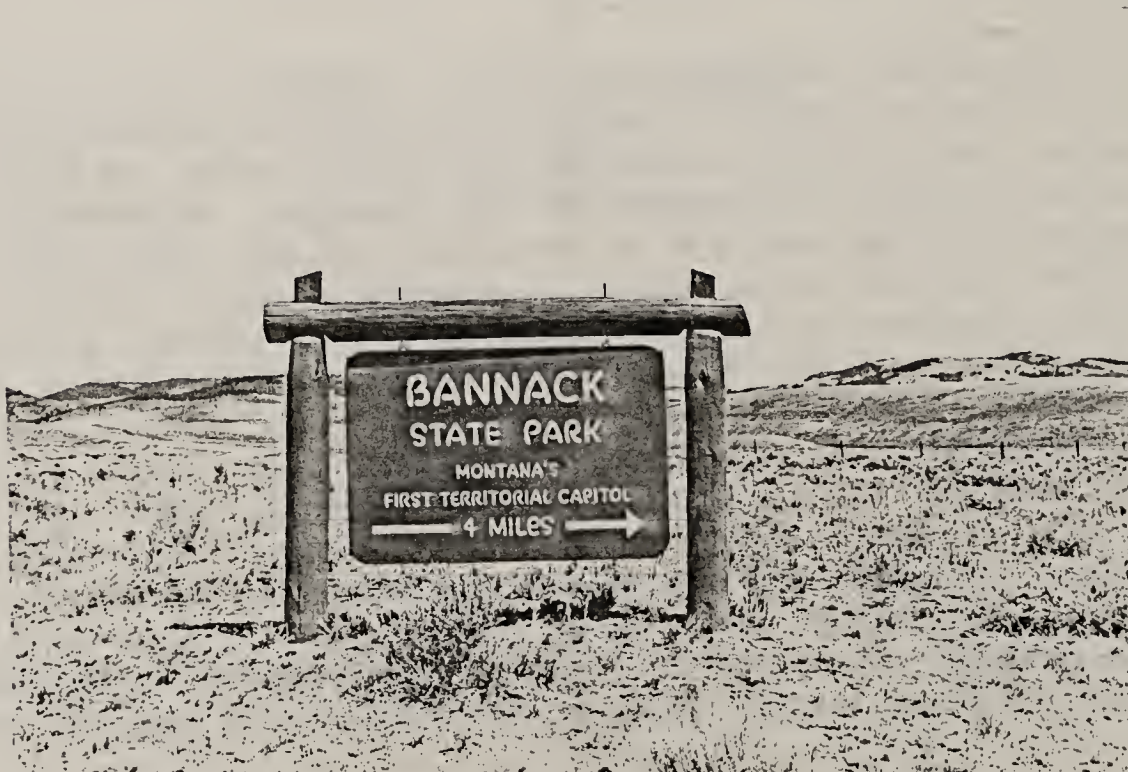
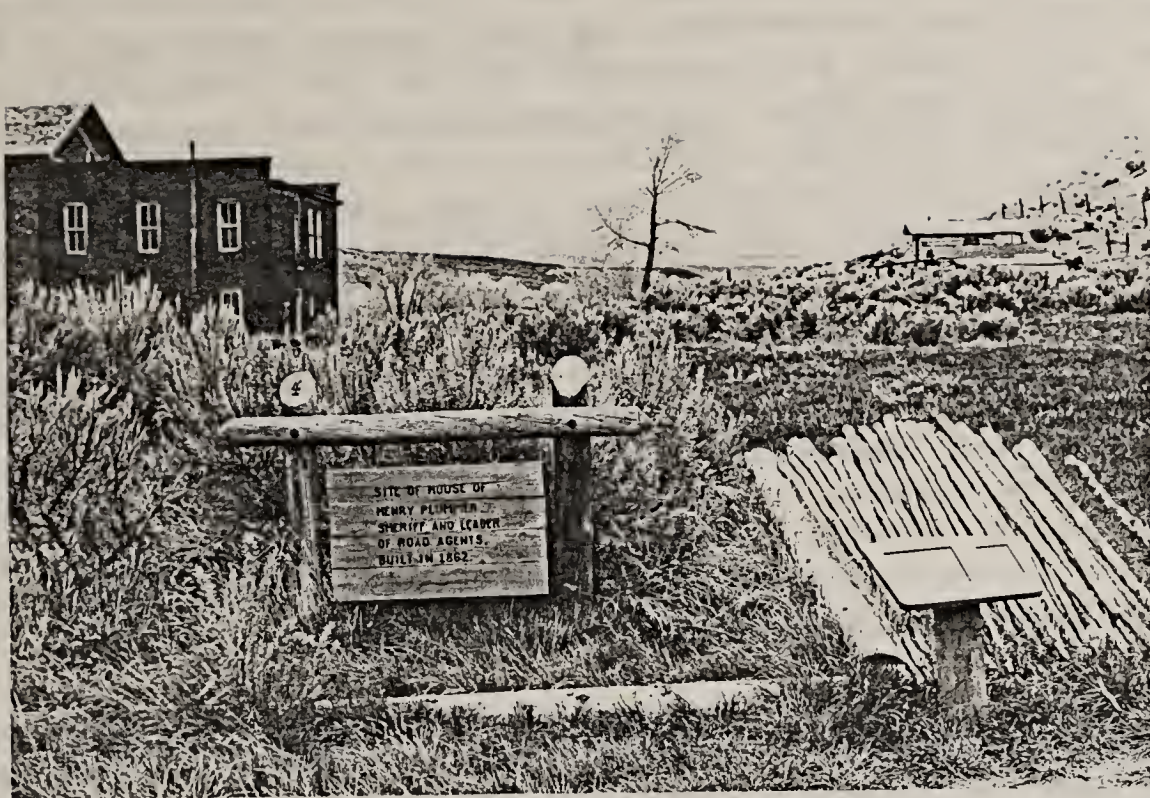
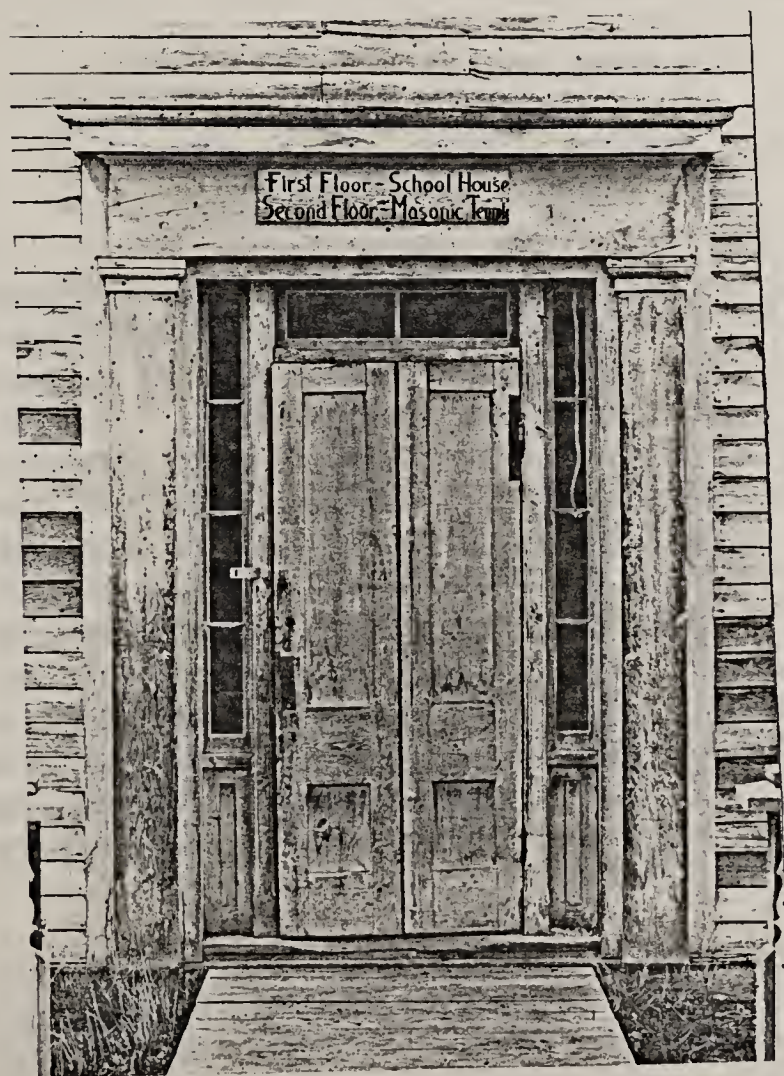
Figures 4-2 through 4-5 illustrate the various types of signage now used in Bannack. It is recommended that a uniform signage system be adopted.
